Final Report of the Potential Fate and Transport of Benzene, 1,4-Dioxane, Lead and Arsenic at the Ringwood Mines Superfund Site Relative to the Wanaque Reservoir

Ringwood Mines Superfund Site

Ringwood, New Jersey

May 2017

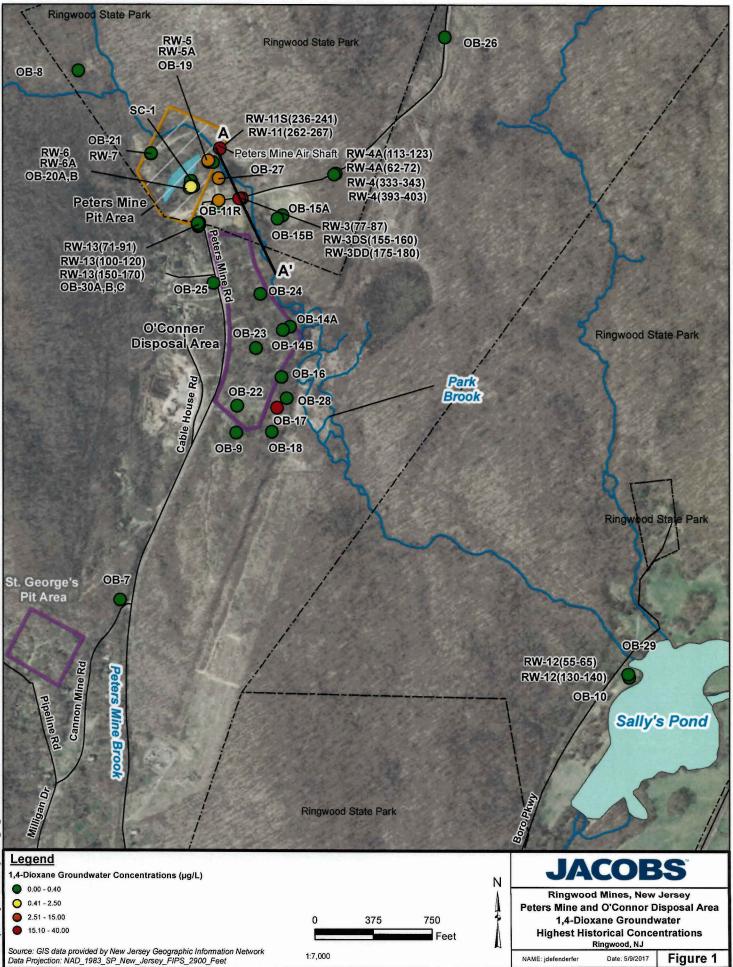
- Figure 1 Ringwood Mines, New Jersey Peters Mine and O'Connor Disposal Area 1,4-Dioxane Groundwater Highest Historical Concentrations
- Figure 2 Ringwood Mines, New Jersey Cannon Mine Area 1,4-Dioxane Groundwater Highest Historical Concentrations
- Figure 3 Peters Mine Pit Area Section A-A' 1,4-Dioxane Concentrations 08/2015

Outlying detections have been observed in Monitoring Well OB-17, located just east of the OCDA (Figure 1), with concentrations ranging from 2.9 to 17.5 μ g/L. Groundwater flow directions in this area are eastward toward Park Brook, suggesting a local source in or near the OCDA. More recent sample results from the OB-17 in February 2017 show concentrations of 16 and 13 μ g/L. The isolated nature of the detections suggests that this is likely indicative of a relatively small zone of contamination, and although some discharge of 1,4-dioxane to Park Brook from this area is likely already occurring, a more widespread zone that would result in elevated concentrations across a larger area downgradient is unlikely. This is supported by the non-detections of 1,4-dioxane in monitoring wells located near OB-17, such as OB-16, OB-18, and OB-28.
